# RICS HomeBuyer Report...

Property address	
Client's name	
l	
Date of inspection	22 <sup>nd</sup> September 2015

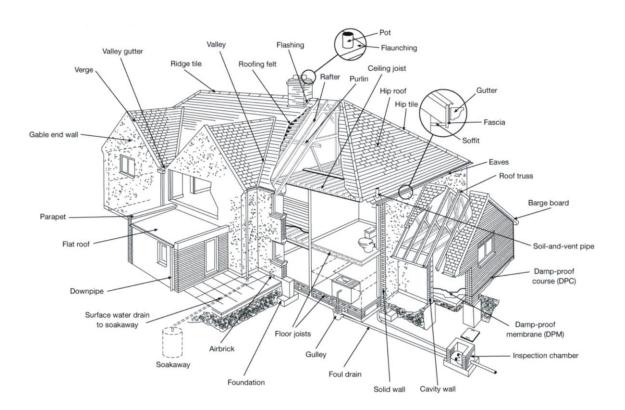
### Typical house diagram

This diagram illustrates where you may find some of the building elements referred to in the report.
