RICS HomeBuyer Report...

Property address	
Client's name	
Pate of inspection	1 st December 2015

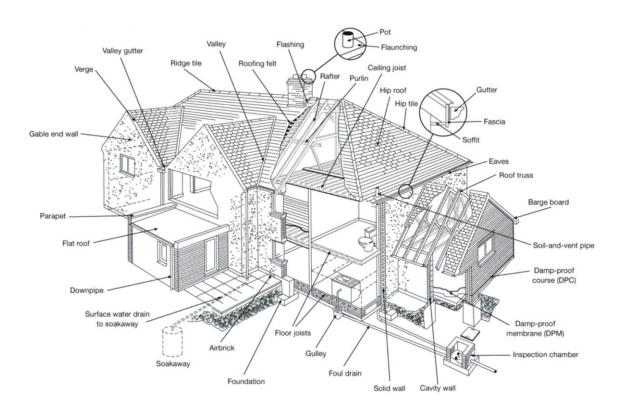
This diagram illustrates where you may find some of the building elements referred to in the report.
