RICS HomeBuyer Report...

Property address		
Client's name		
Date of inspection	13 th November 2015

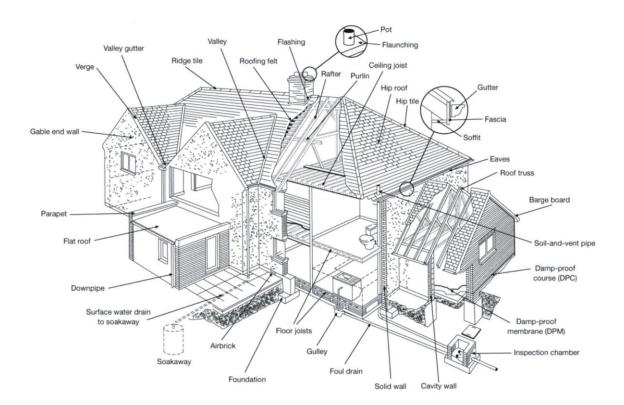
Typical house diagram

This diagram illustrates where you may find some of the building elements referred to in the report.
