RICS HomeBuyer Report...

Property address	
Client's name	Mr
Date of inspection	6 th October 2016

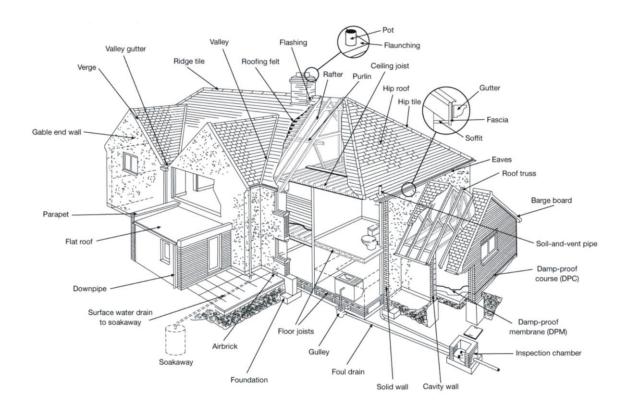
This diagram illustrates where you may find some of the building elements referred to in the report.
